*Case and photos courtesy of Dr. John Derango*

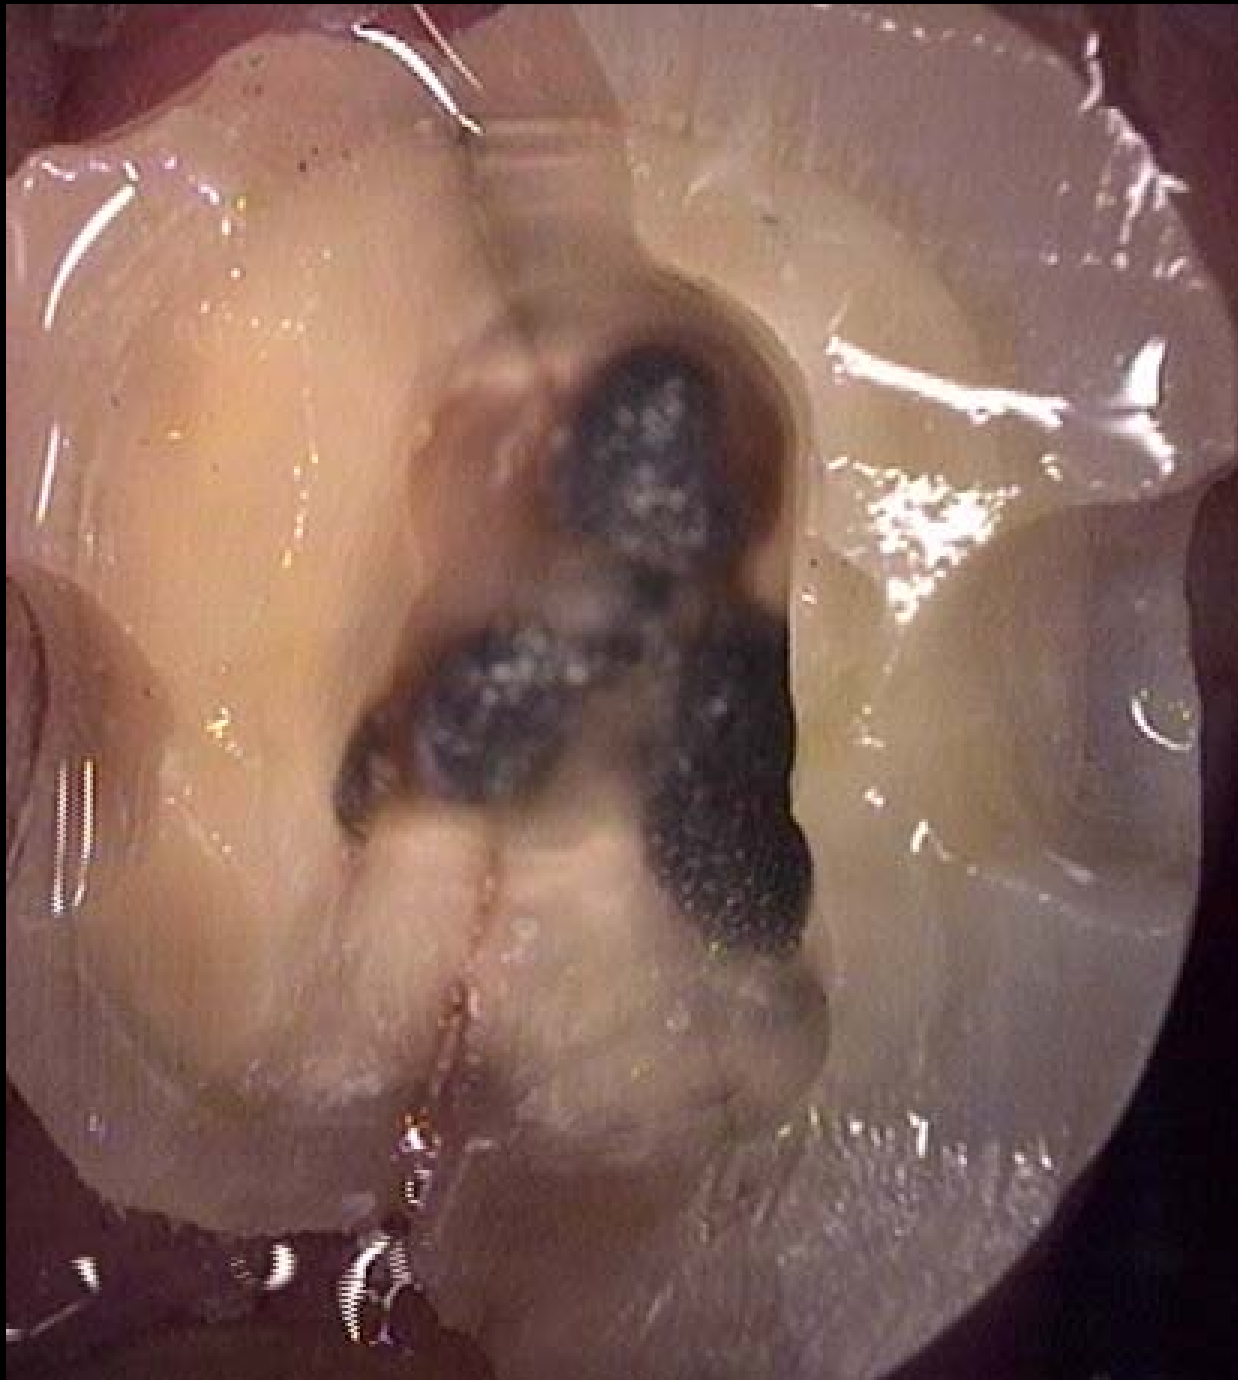
Endodontics done a year prior. Patient did not follow-up with crown. No symptoms presented.
